# HOW TO READ YOUR ROOF

**UNDERSTANDING THE NATURAL AGING  
PROCESS OF ASPHALT SHINGLES**

**TAMKO**<sup>®</sup>  
BUILDING PRODUCTS

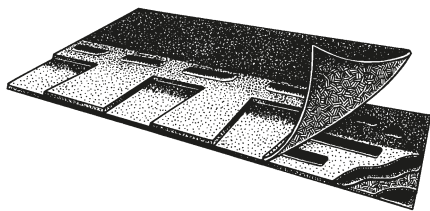
Laminated shingles consist of two or more layers bonded together, giving them added dimension for a shake-like appearance.

3-tab shingles are made with a single layer of fiberglass mat.

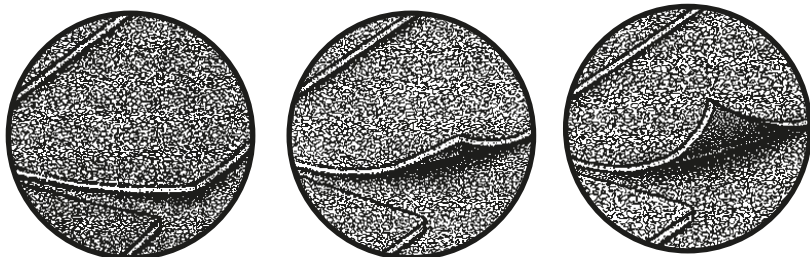
## CURLING

Curling is a common phenomenon in some shingles and is not a defect. It is natural for asphalt to age and asphalt layers to shrink with time. This shrinkage may result in the slight curling of the edges of the shingle.

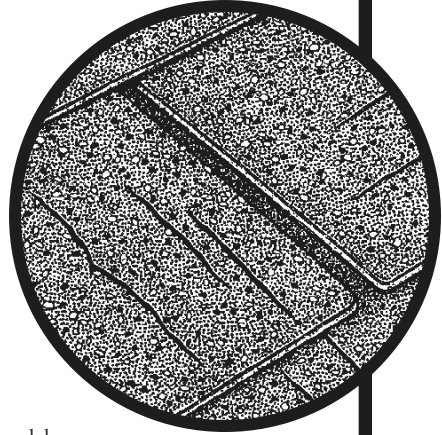
## **SURFACE CRACKING**

While minor cracks may not be noticeable from the ground, you might spot them while hanging your Christmas lights. Intense heat from the sun often allows protective asphalt oils to deplete, causing minor cracks. Keep in mind that these normal weathering characteristics are not cause for alarm as long as your shingles are still performing their intended purpose of shedding water. Cracks that penetrate through the fiberglass or organic mat should be investigated.

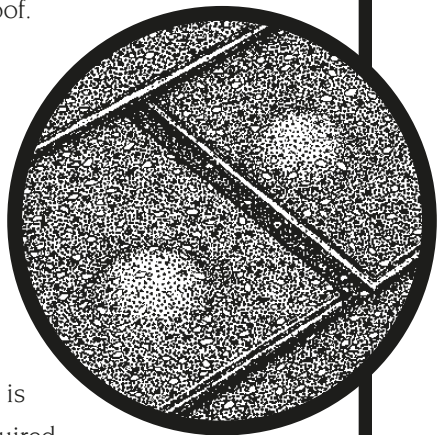
## **BLISTERS**

Occasionally, naturally occurring small, circular raised areas known as blisters may appear on your roof. These pockets may vary in size and be open (exposing the asphalt) or closed. Blisters are often a direct result of underventilated attics or excessive use of plastic cement. Closed blisters are not reason for concern as long as your shingles are still performing their intended purpose of shedding water. However, open blisters do mean asphalt is exposed and immediate attention is required.

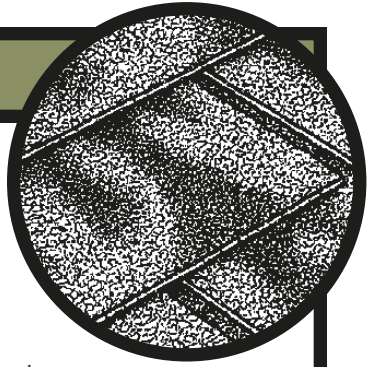
## ALGAE STAINS

In moist, humid areas, dark brown or black patches may appear on roofs. These streaks result in a dirty rooftop, often more visible on lighter-colored shingles. This naturally occurring stain is caused by algae growth and will not affect your shingles' ability to shed water. Algae discoloration should not be confused with moss or tree droppings, which typically produce only localized discoloration.

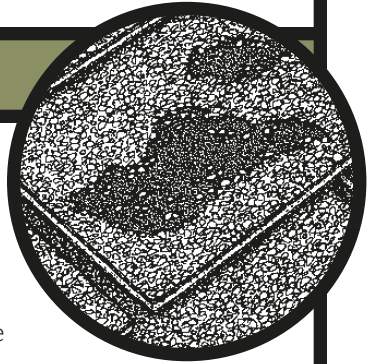
## GRANULE LOSS

Since extra granules are used in the manufacturing process, some granule loss is to be expected during the early years of your roof. Other factors, such as foot traffic, hail, snow or brushing tree limbs, may cause loose granules. However, exposed asphalt due to granule loss is a reason for concern and requires immediate attention.

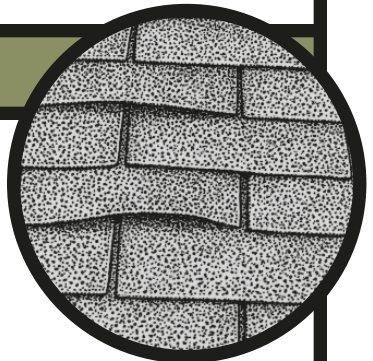
## BUCKLING

While not technically a sign of aging, a distortion of shingles known as buckling can occur months after original application. Lack of adequate attic ventilation can increase the moisture content of the decking material. This may cause expansion and movement of the wood deck to buckle shingles.
